### Renovation of the stone lion sculptures in front of the main courtyard of the Presidential Palace.

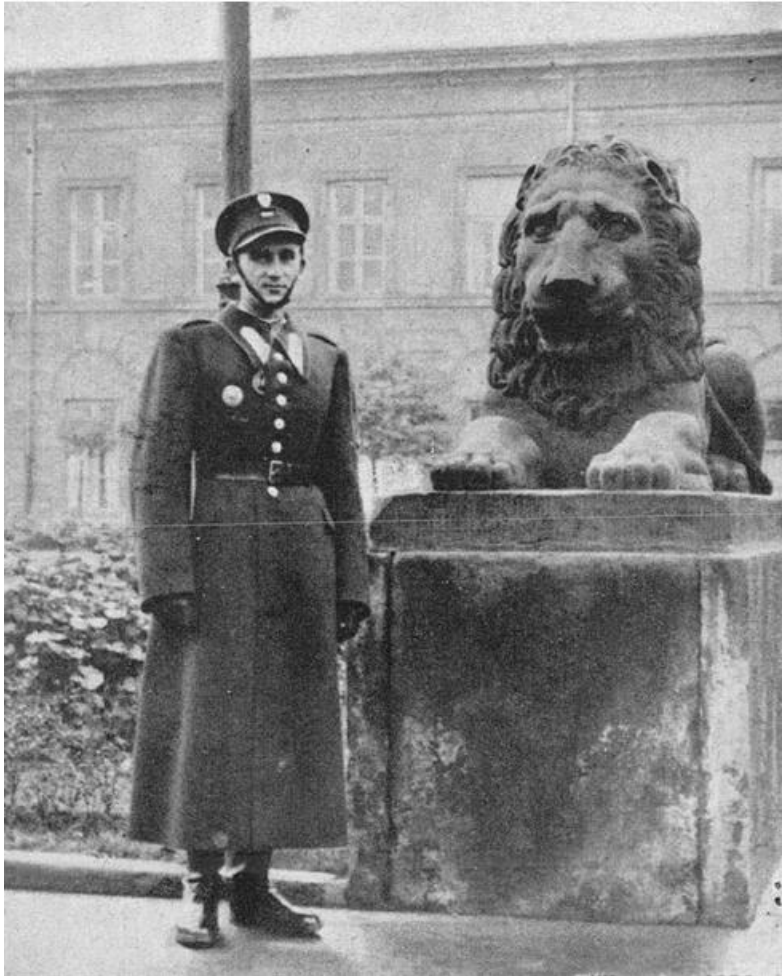
A picture of the lion on the right side of the Northern entrance made in 1938,  
„Na posterunku. Gazeta Policji Państwowej” [*On the Guard. State Police Newspaper*], 1938, Y. 20, issue No 47 (20 November 1938),  
[Polona.pl](http://Polona.pl).

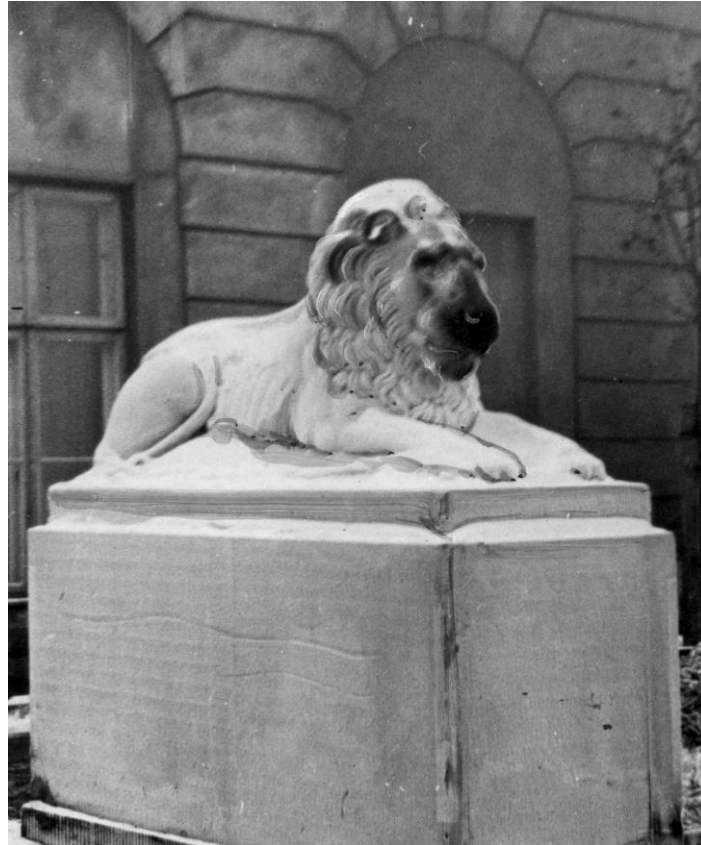
A picture of the lion on the left side of the Northern entrance made in January 1943,  
*Collection of the Press Publishing House Kraków-Warszawa*, National Digital Archives,  
catalogue number [3/2/0/-/5708a](#).

During the Warsaw Uprising, the sculptures suffered a great deal of damage as a result of the fighting in the Krakowskie Przedmieście area. The lion on the left side of the Southern entrance suffered the most damage to its body, muzzle and paws. The sculpture to the right of the Northern entrance, on the other hand, suffered structural cracks to its head and rump. On the surface of all four lions, there were numerous bullet holes.

After 1945, thanks to the efforts of the sculptors and conservators, the lions were reassembled into one whole, using previously collected fragments of various dimensions. A traditional method of Dutchman repair was applied with the use of mineral mortar, which unfortunately favours the penetration of rainwater inside the sculptures and causes the patches to burst, cracks to recur and intensive growth of algae and mosses in the joints. In addition, Szydłowiec sandstone from the Śmiłów deposit was also used for the restorations, with a light grey colour that differs from that of the Bolesławiec stone used by Landini. This stone is also less resistant to weathering. As a result, the sculptures, permanently exposed to the destructive effects of the weather, have become an object of constant concern for conservators.

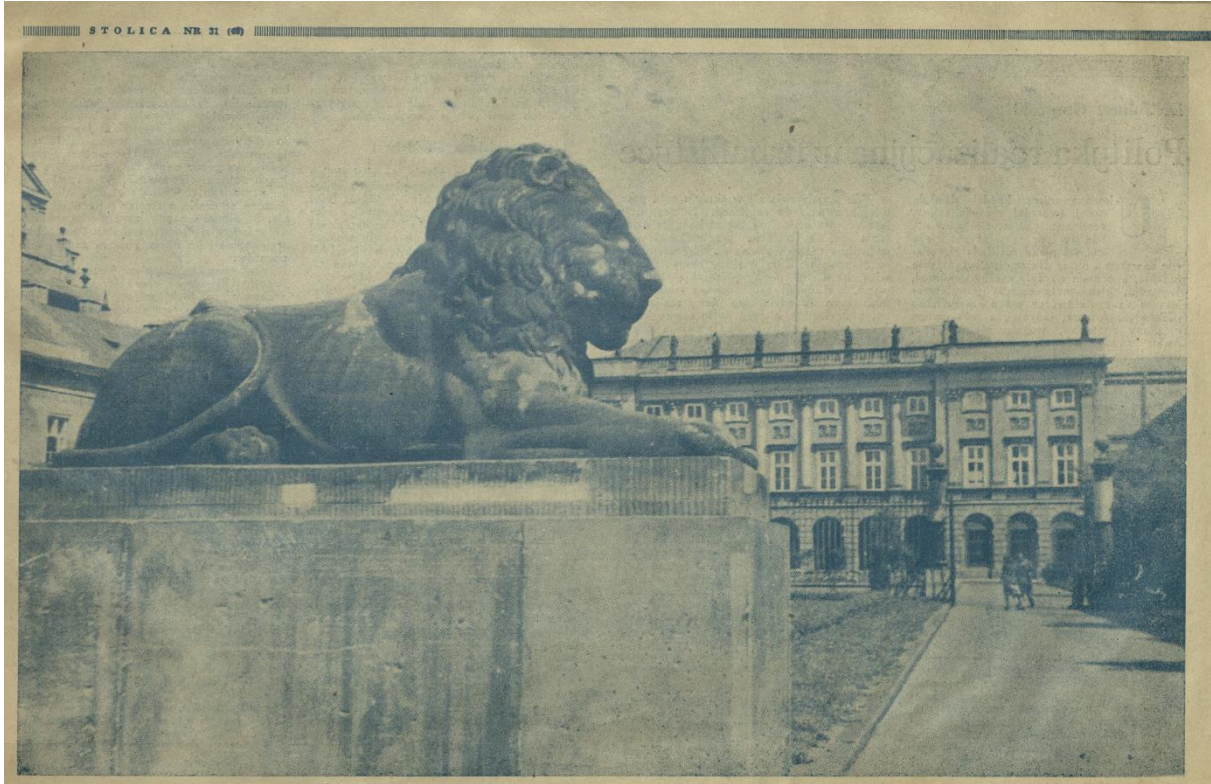
The sculpture most severely damaged during the Warsaw Uprising (the lion on the left side of the Southern entrance) following restoration works. "Stolica" ["The Capital"], issue No 31, 1947, page 6, [Mazovian Digital Library](#).

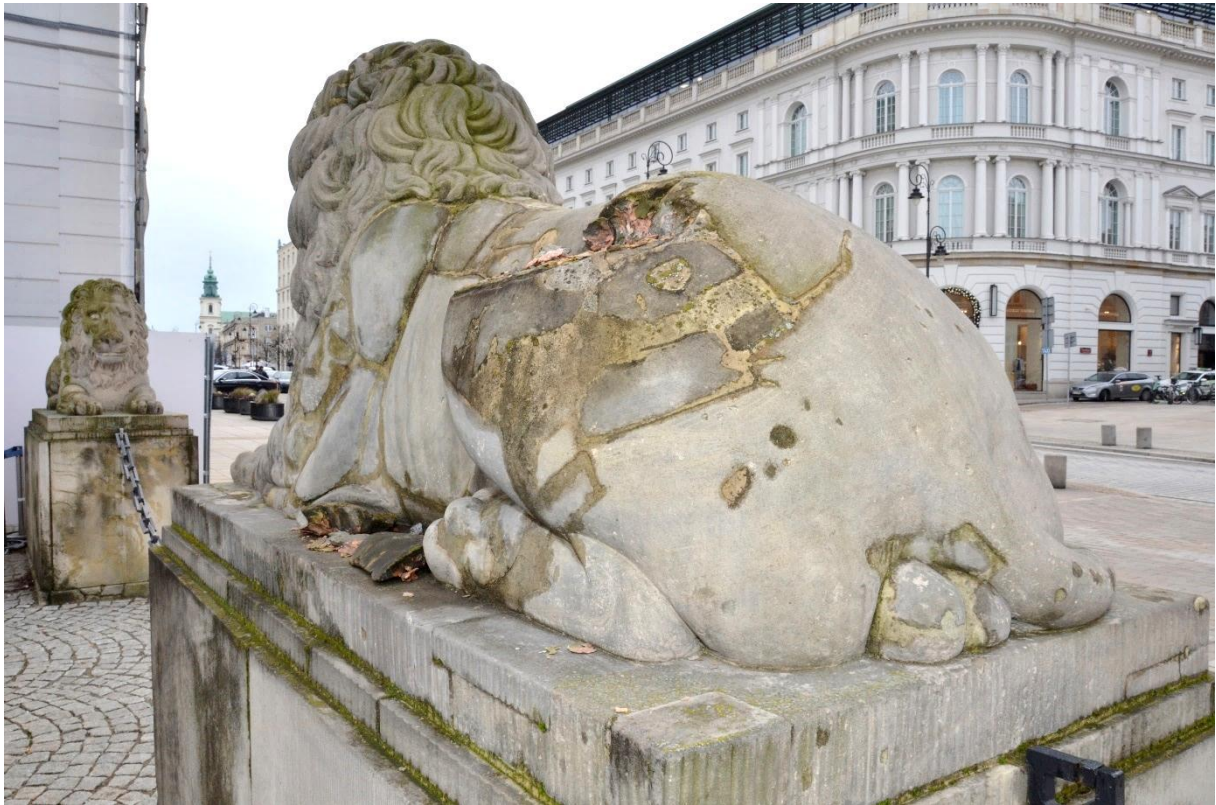
Wojciech Roman, *Lion L3 – rump view*. Note the completely detached stone fragments (stacked next to the sculpture),  
[in:] *Program prac konserwatorskich [The conservation work programme]*, developed by Wojciech Roman, Warsaw 2023, photo 38, page 41.

In the 21st century, renovation works were carried out in 2002 and 2013. The effort was of an ad hoc prophylaxis nature and aimed at saving the sculptures from environmental degradation. The lions have now been transported to a conservation studio, where they are undergoing a comprehensive restoration that will permanently protect them from weathering. As a first step, external layers and loose patches will be removed. The surface of the stone will then be disinfected and thoroughly cleaned using chemical, laser and dry ice blasting methods. Mineral mortar fillings that no longer serve their purpose will be mechanically removed. The conservators will also decide on any structural reinforcements for the sculptures in the form of rods or carbon fibre bands. New Dutchman repairs will be inserted using modern stone adhesives, and fillings that do not require Dutchman repair will be made of durable and pigmented mineral mortars. On completion of the work, disinfection by low-pressure spraying will be repeated, followed by colour unification. Finally, the surface of the sculptures

will be covered with a hydrophobic protective layer.

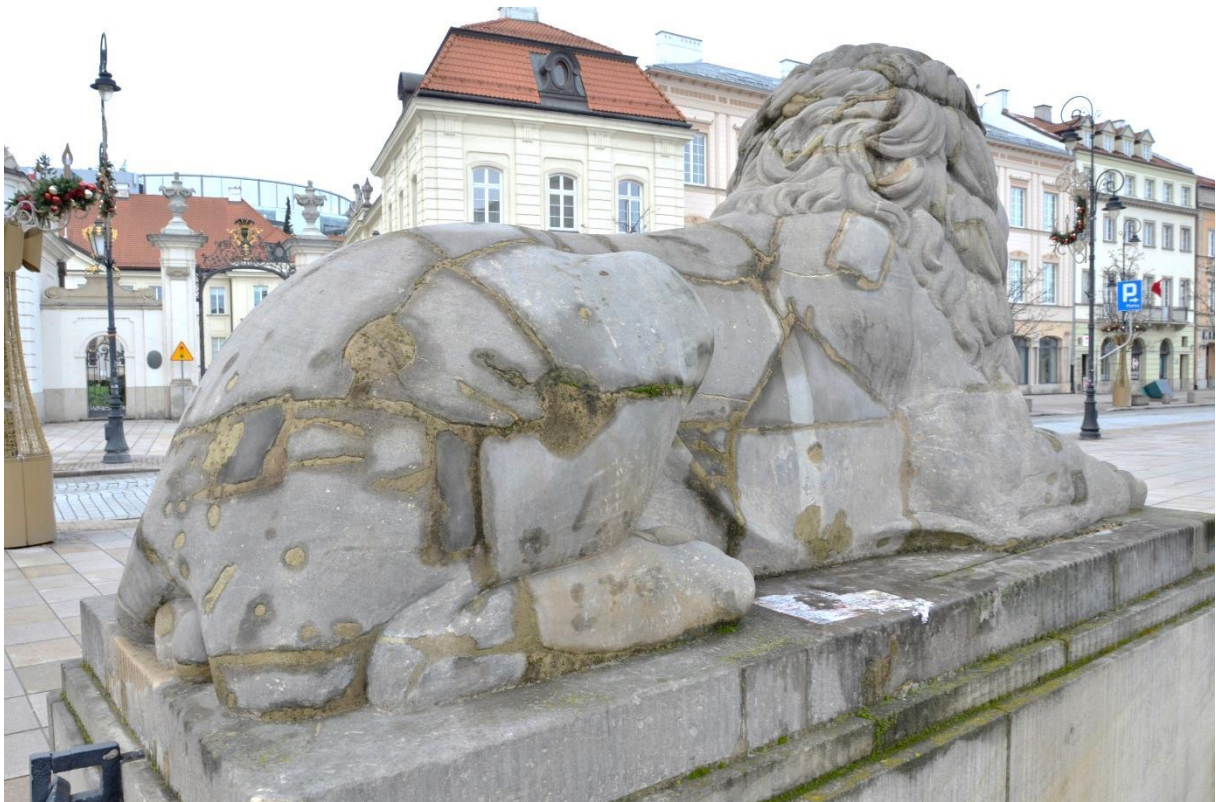
Wojciech Roman, Scale of damage to the L2 sculpture - the whole trunk is composed of separate fragments,

[w:] *Program prac konserwatorskich* [The conservation work programme] developed by Wojciech Roman, Warsaw 2023, photo 53, page 49.
